Figure 1. Location of the Los Alamos National Laboratory and Study Area (Source: LANL 1998a).

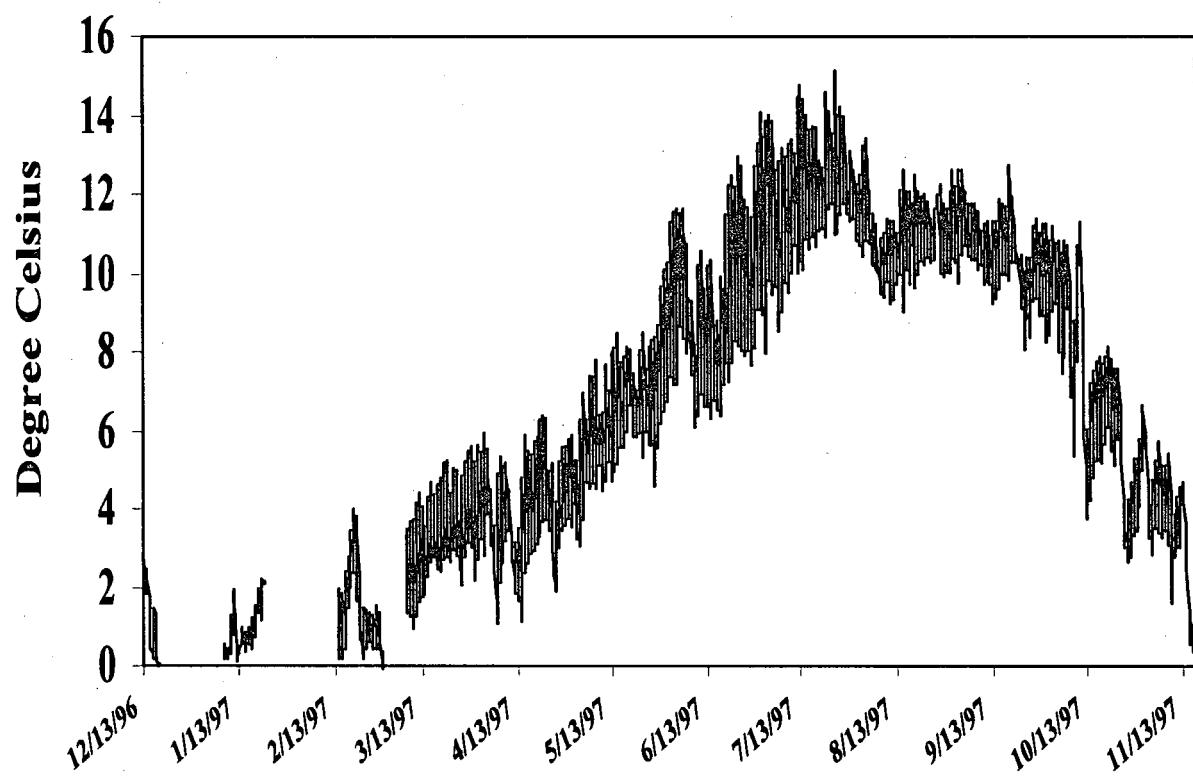
Figure 26. Water Temperature ($^{\circ}\text{C}$) in the Los Alamos Canyon Stream Segment, 1996-1997.

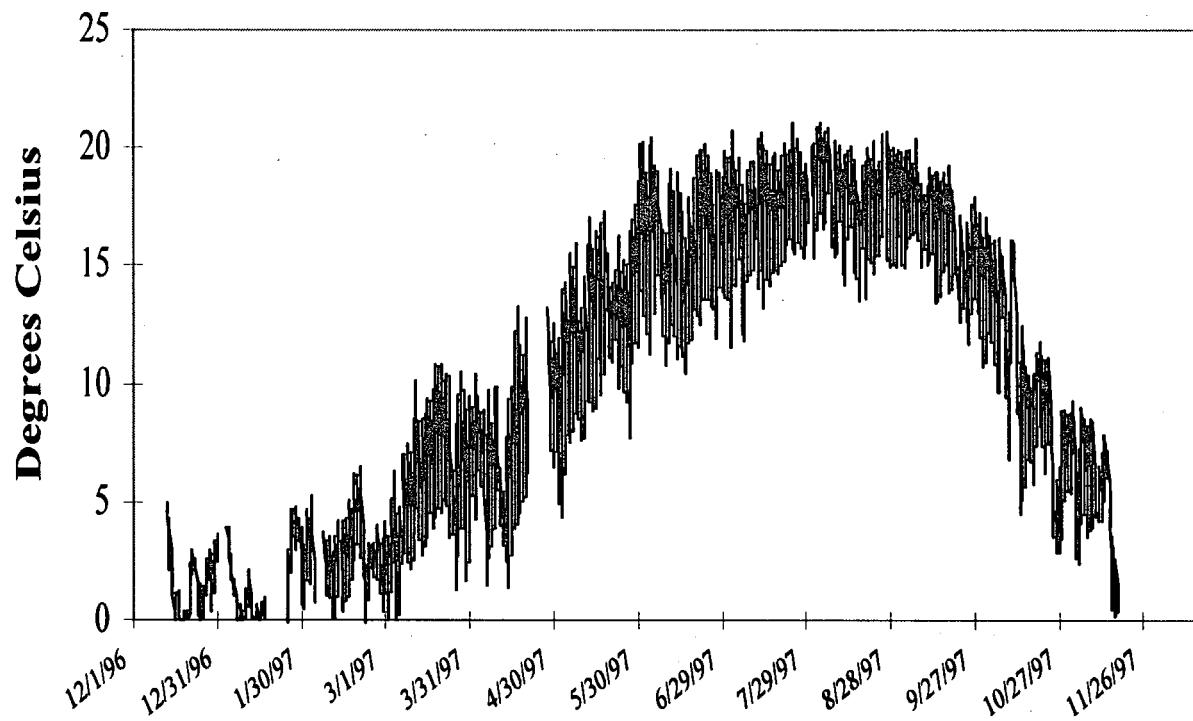
Figure 27. Water Temperature ($^{\circ}\text{C}$) in the Sandia Canyon Stream Segment, 1996-1997.

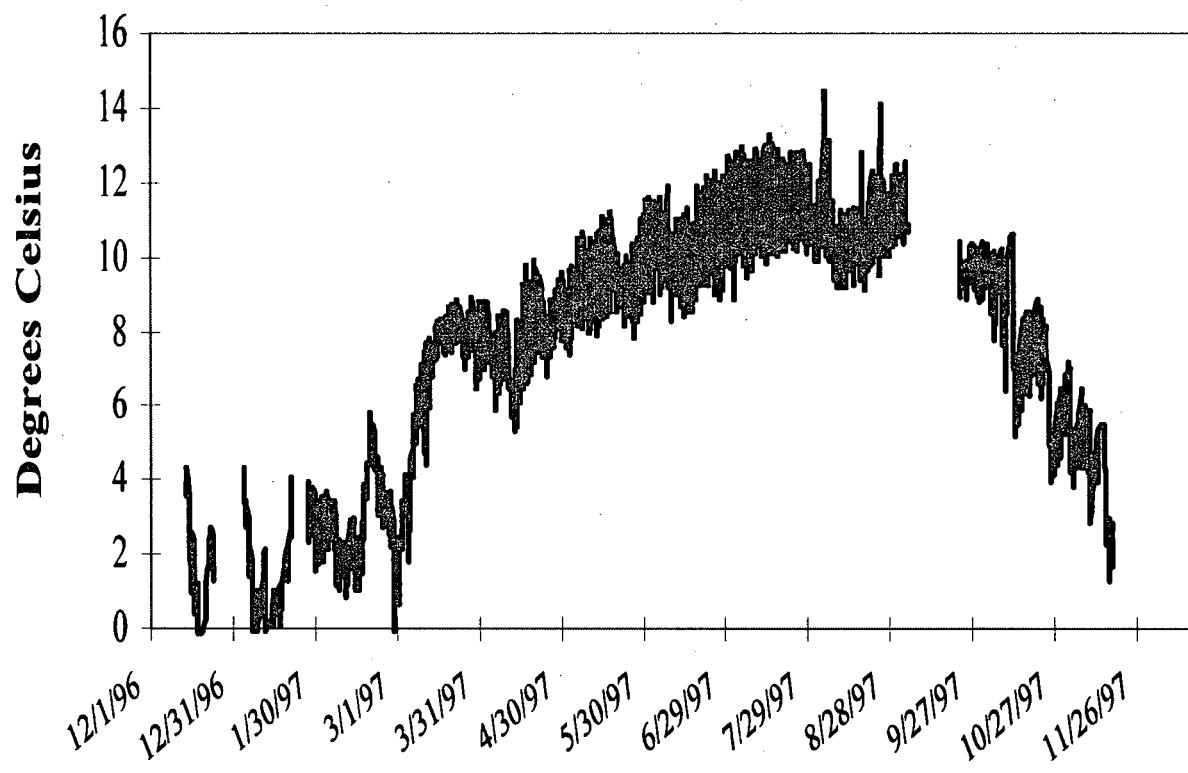
Figure 28. Water Temperature ($^{\circ}\text{C}$) in the Pajarito Canyon Stream Segment, 1996-1997.

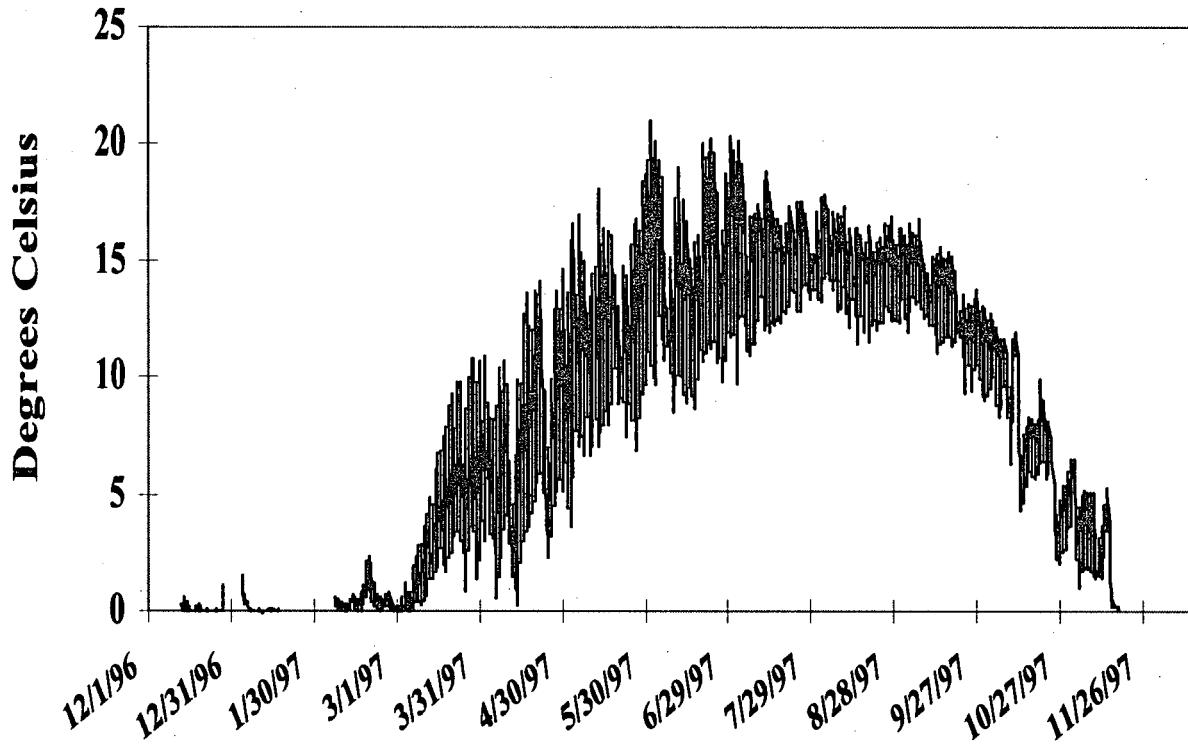
Figure 29. Water Temperature ($^{\circ}\text{C}$) in the Valle Canyon Stream Segment, 1996-1997.

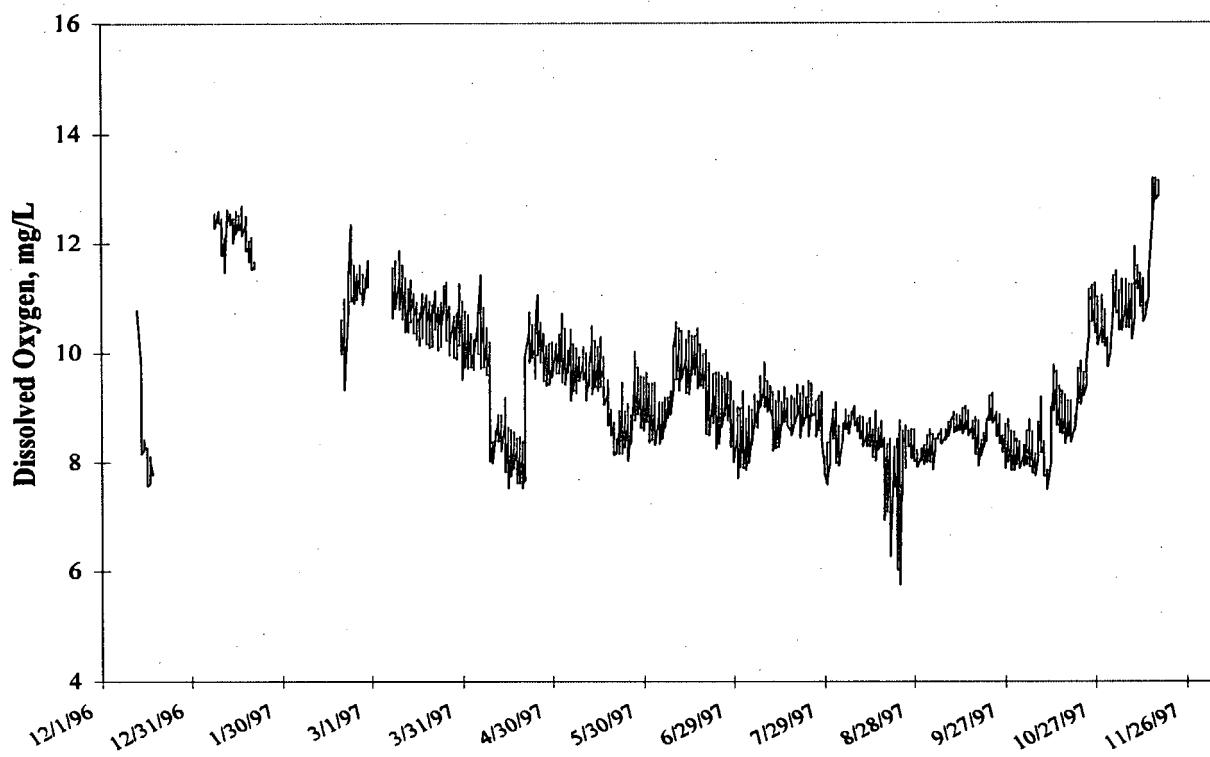
Figure 30. Dissolved Oxygen (mg/L) in the Los Alamos Canyon Stream Segment, 1996-1997.

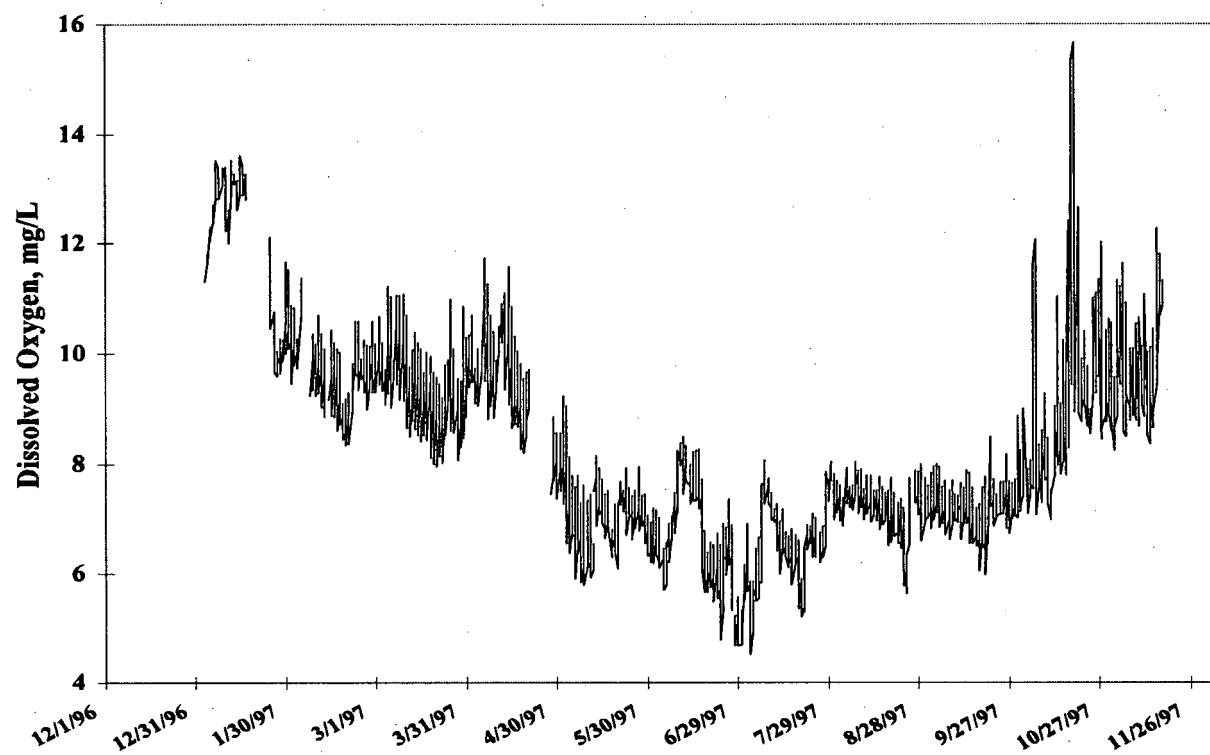
Figure 31. Dissolved Oxygen (mg/L) in the Sandia Canyon Stream Segment, 1996-1997.

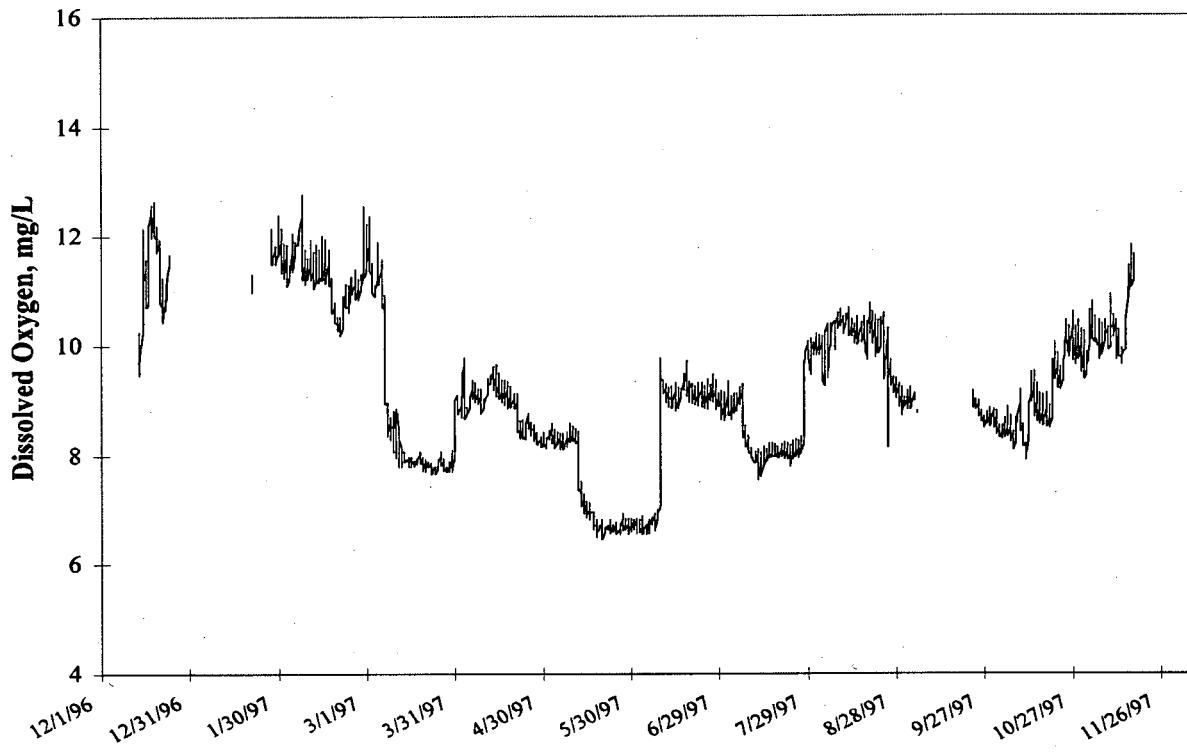
Figure 32. Dissolved Oxygen (mg/L) in the Pajarito Canyon Stream Segment, 1996-1997.

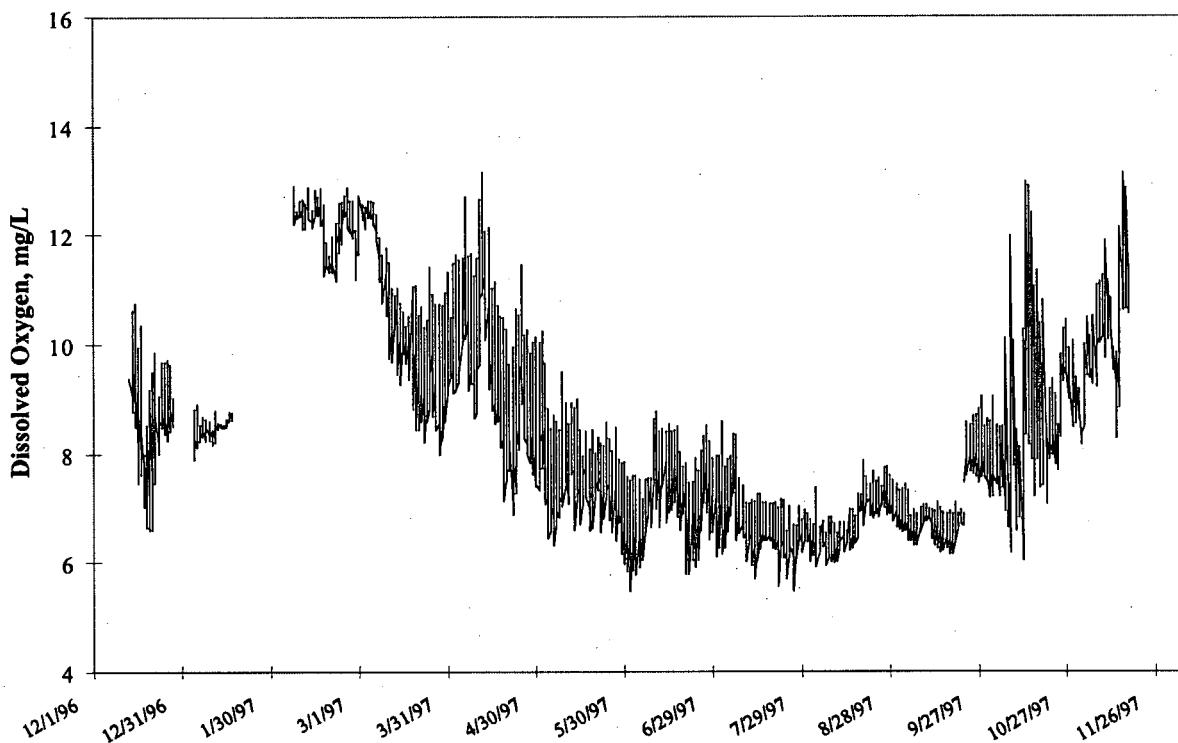
Figure 33. Dissolved Oxygen (mg/L) in the Valle Canyon Stream Segment, 1996-1997.

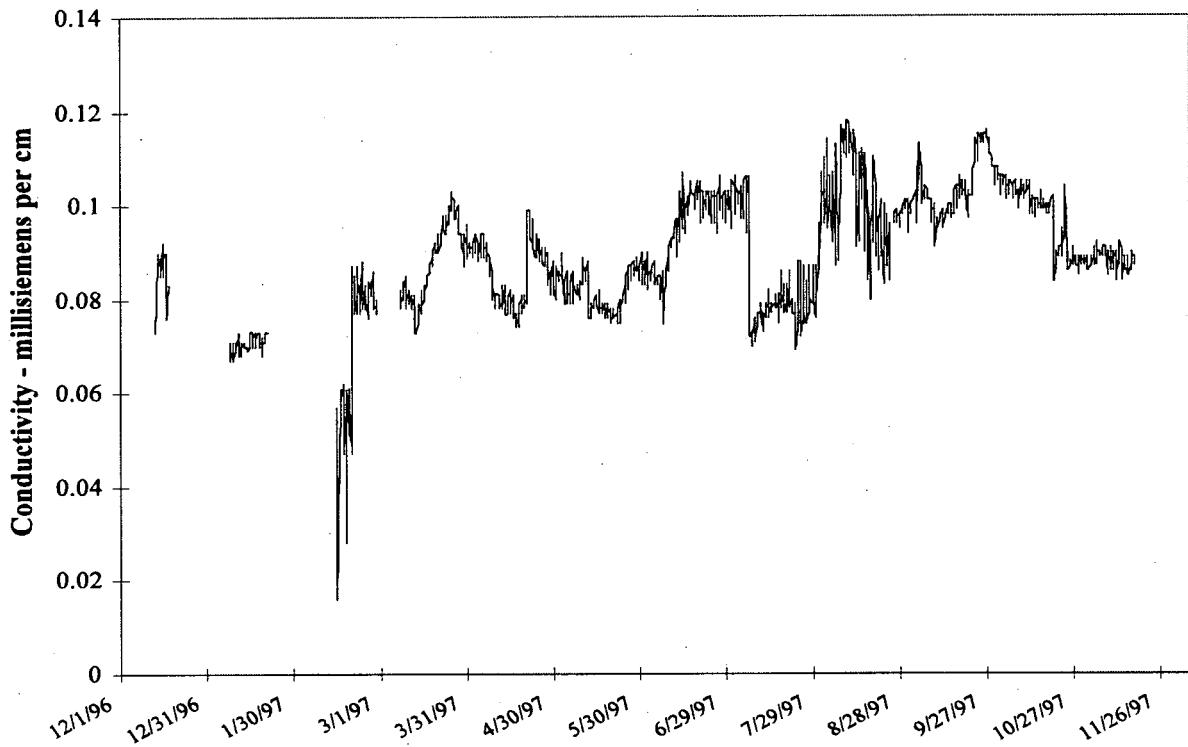
Figure 34. Conductivity (mS/cm) in the Los Alamos Canyon Stream Segment, 1996-1997.

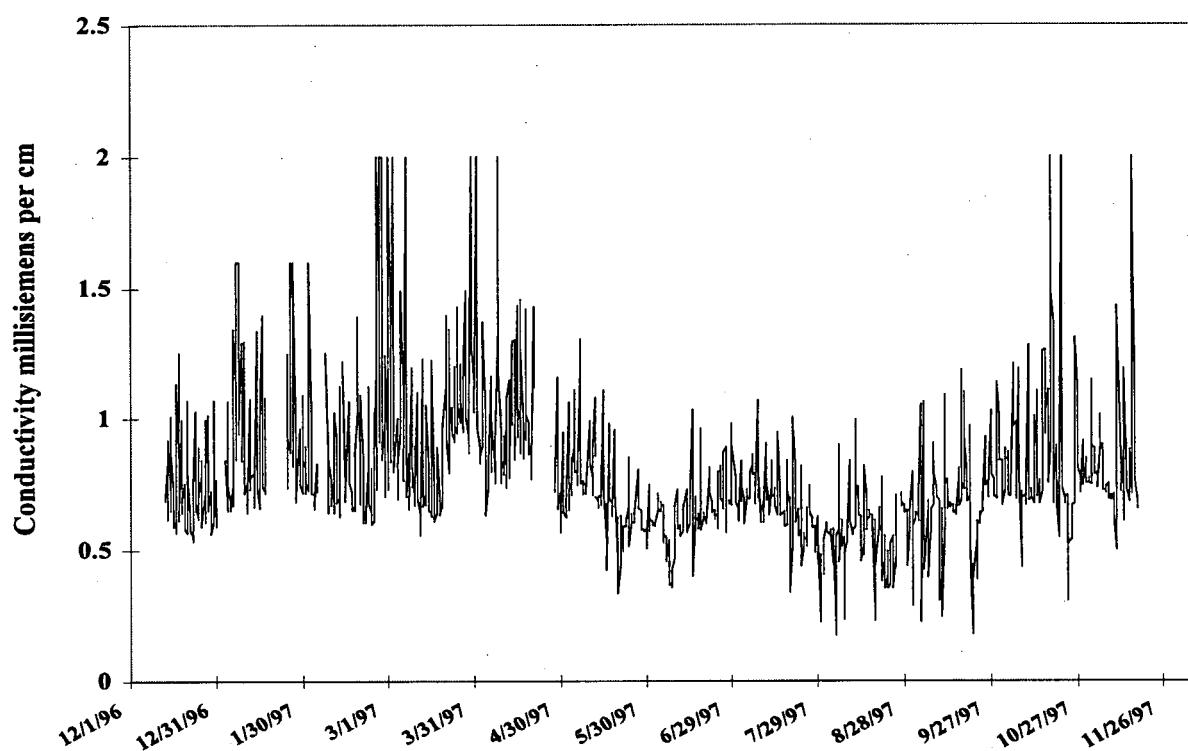
Figure 35. Conductivity (mS/cm) in the Sandia Canyon Stream Segment, 1996-1997.

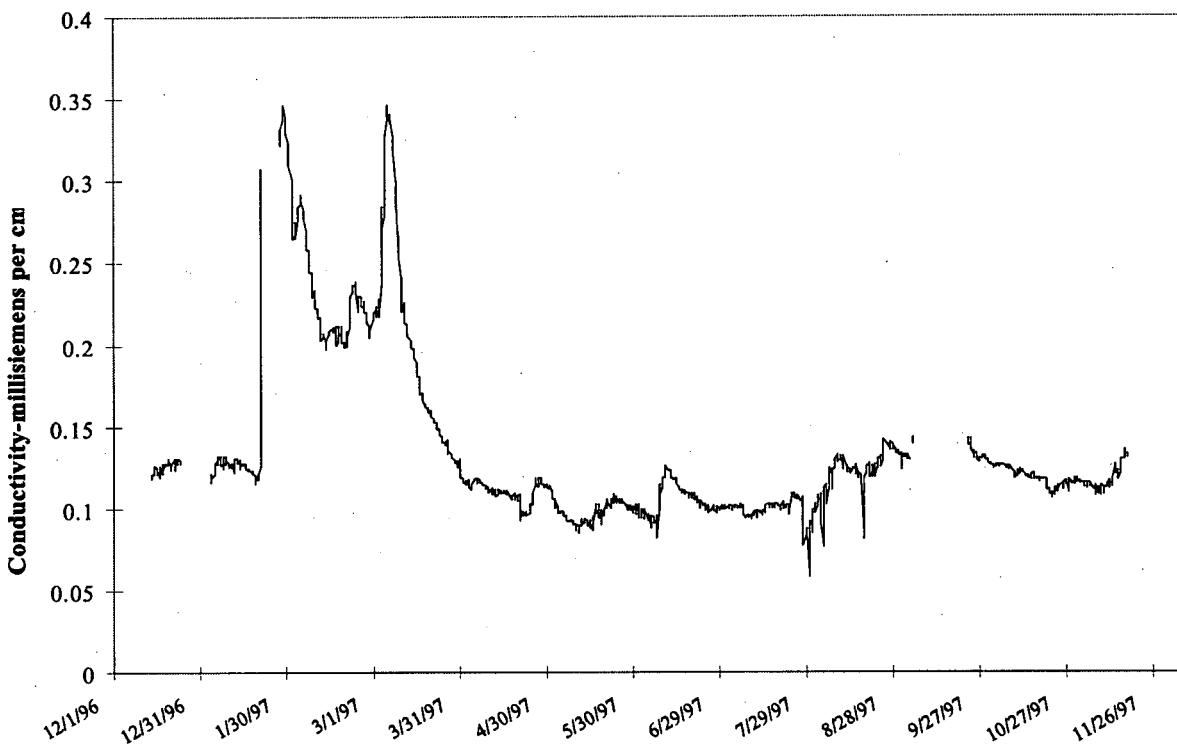
Figure 36. Conductivity (mS/cm) in the Pajarito Canyon Stream Segment, 1996-1997.

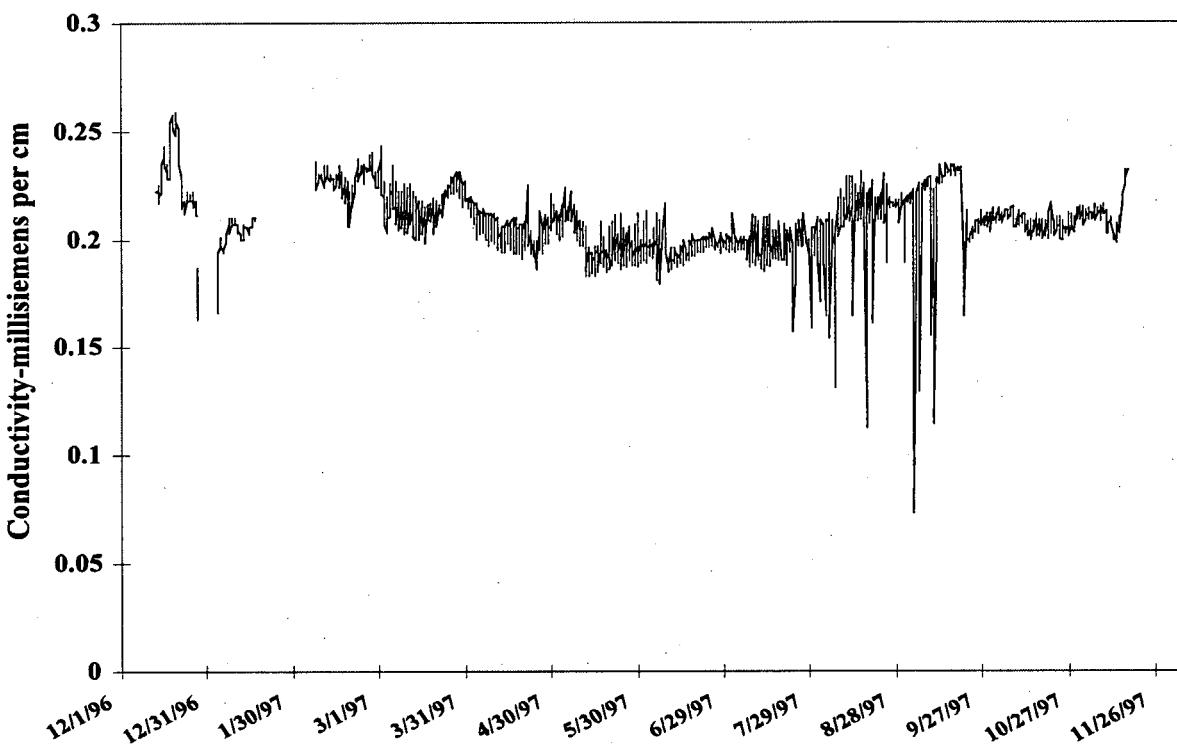
Figure 37. Conductivity (mS/cm) in the Valle Canyon Stream Segment, 1996-1997.

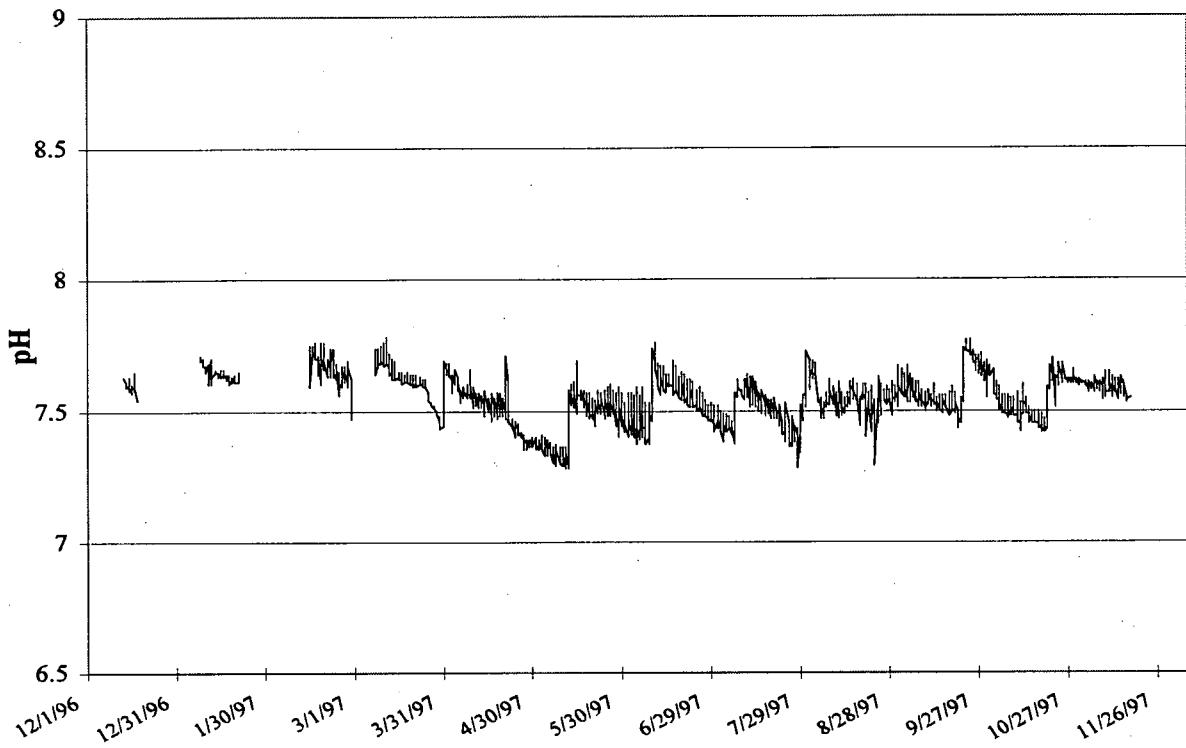
Figure 38. The pH in the Los Alamos Canyon Stream Segment, 1996-1997.

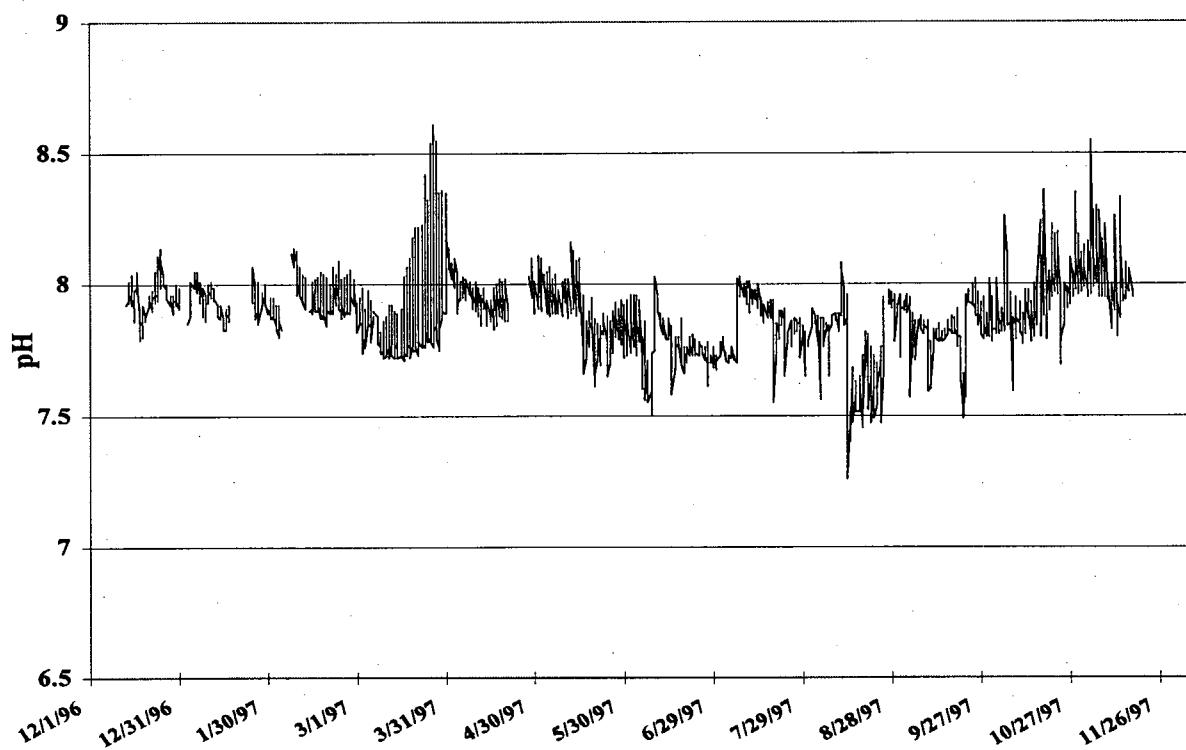
Figure 39. The pH in the Sandia Canyon Stream Segment, 1996-1997.

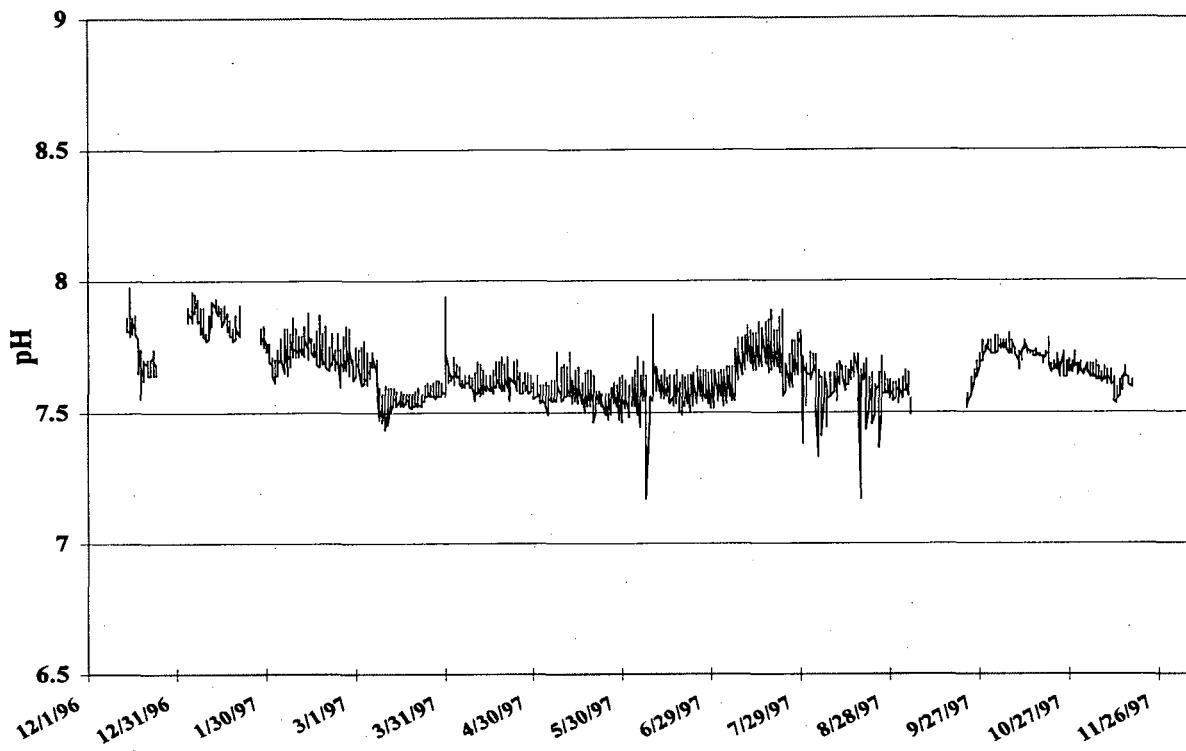
Figure 40. The pH in the Pajarito Canyon Stream Segment, 1996-1997.

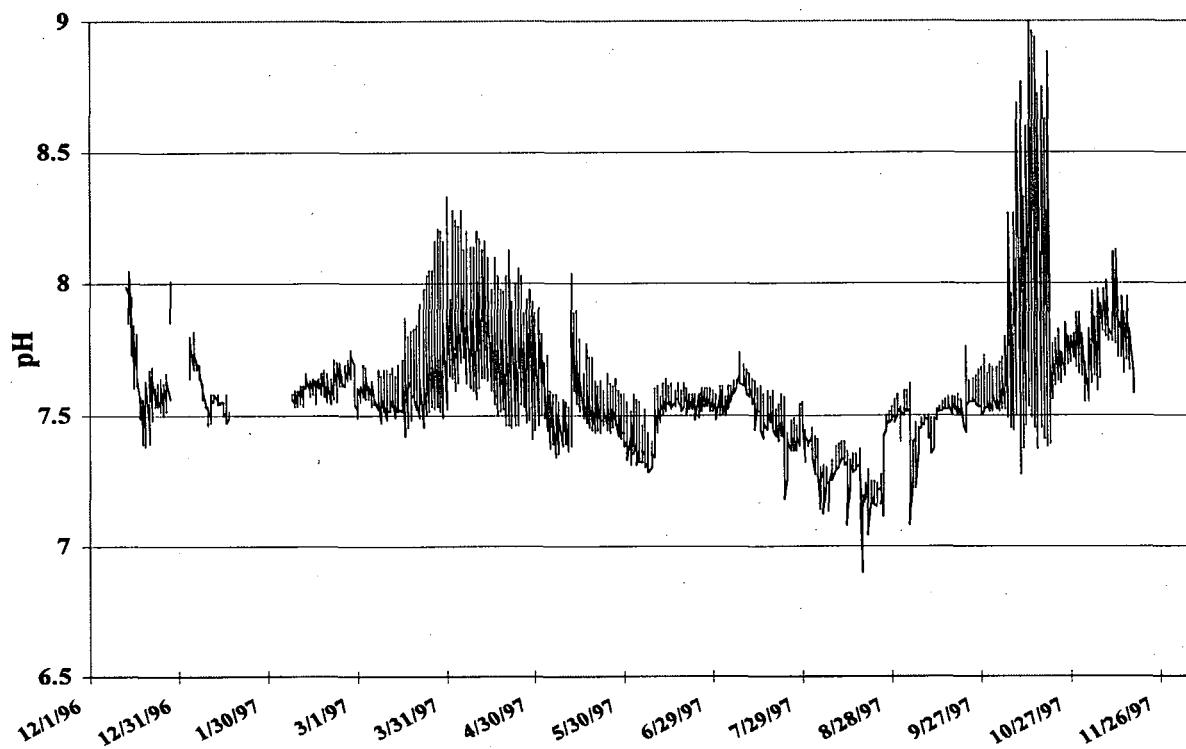
Figure 41. The pH in the Valle Canyon Stream Segment, 1996-1997.

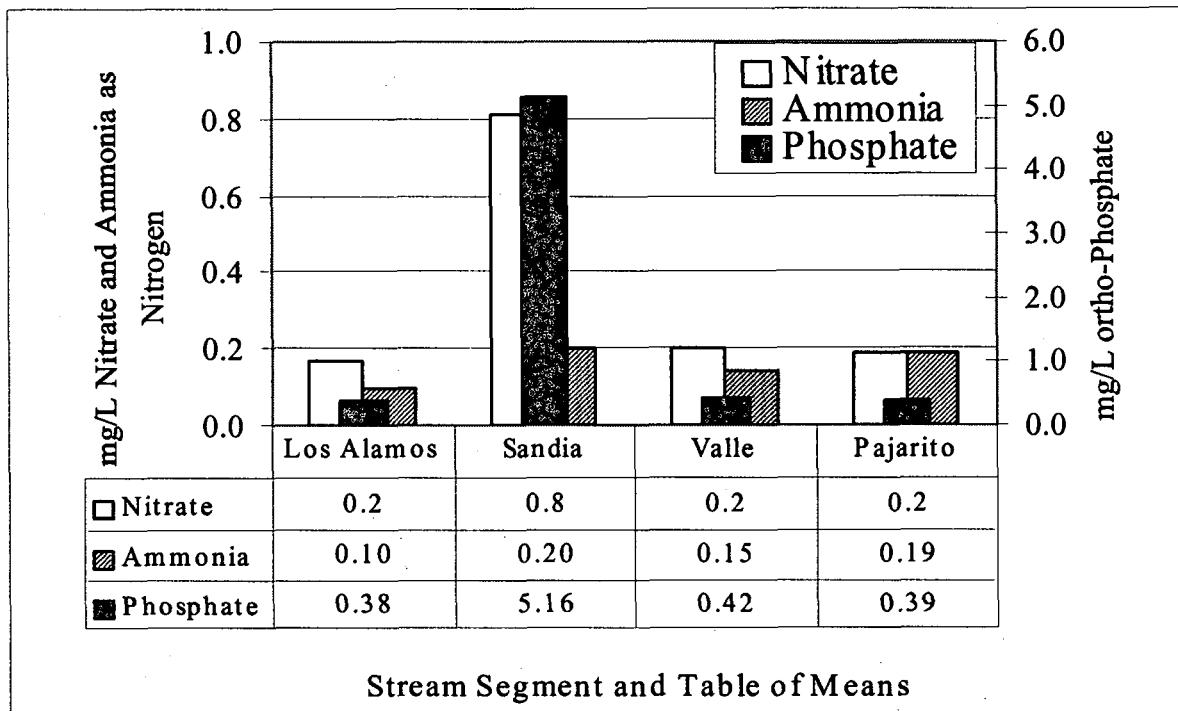
Figure 61. Average Nutrient Content (Nitrate/Nitrite and Ammonia as Nitrogen, and Phosphorus as Ortho-Phosphate) of Canyon Stream Segments, 1997.

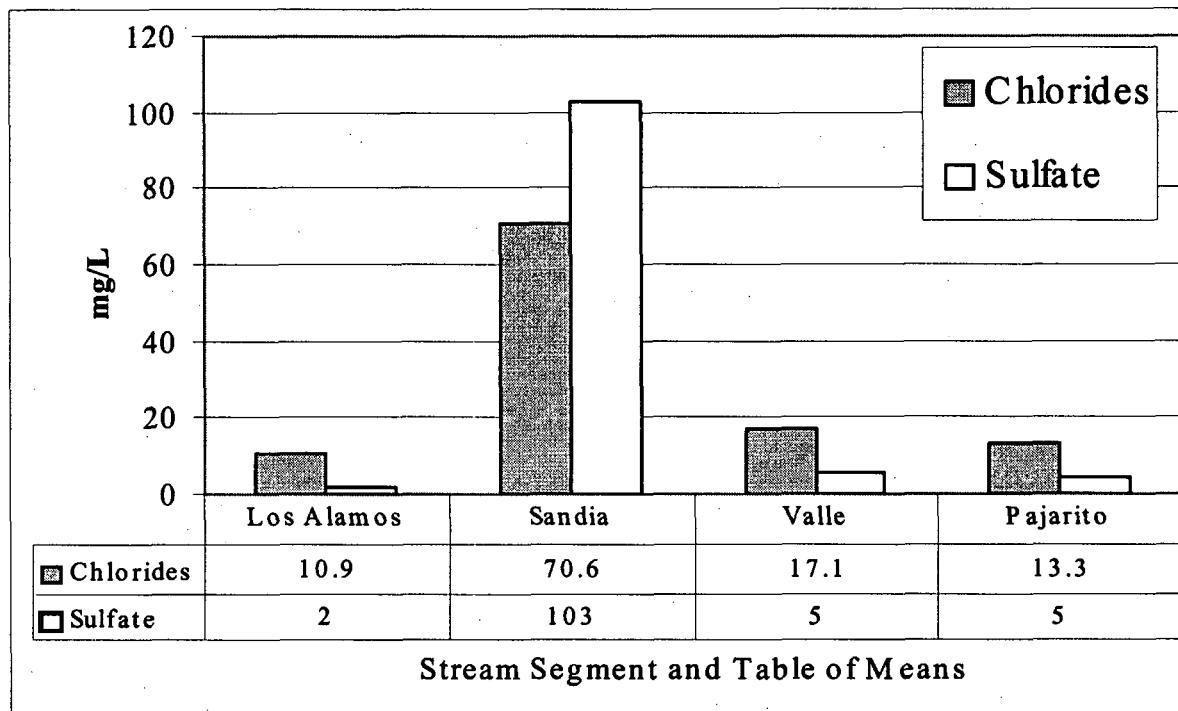
Figure 62. Average Chloride and Sulfate Content of Canyon Stream Segments, 1997.

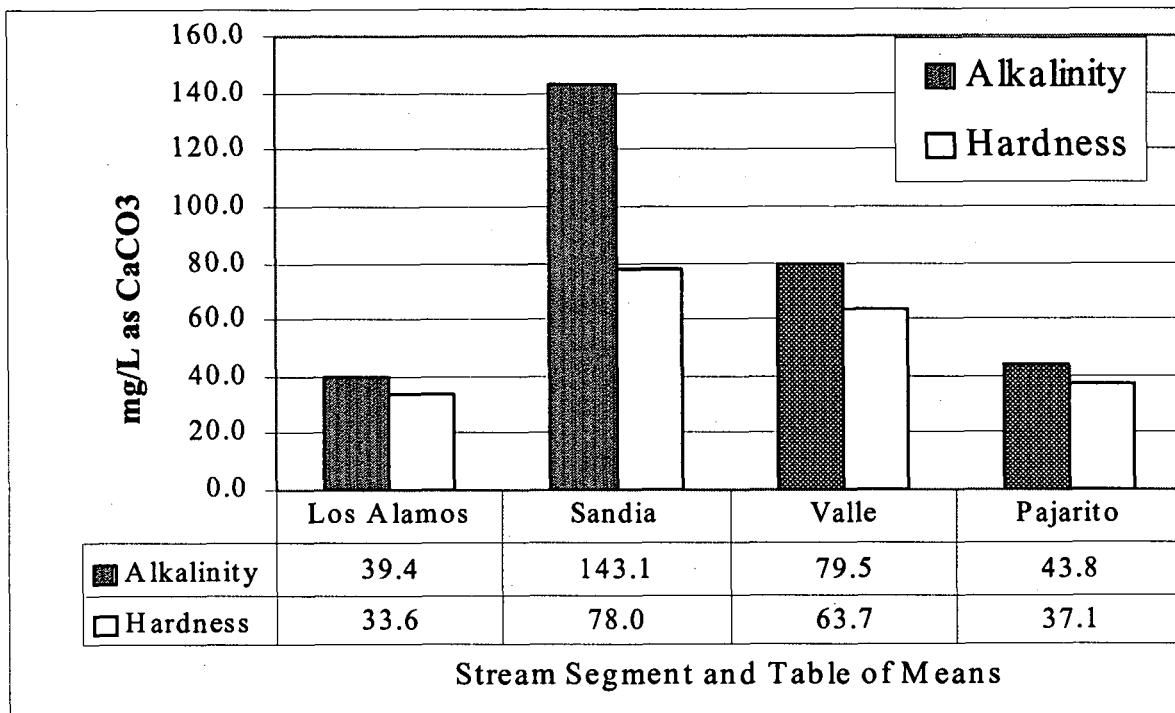
Figure 63. Average Alkalinity and Hardness (mg/L as CaCO₃) of Stream Segments, 1997.

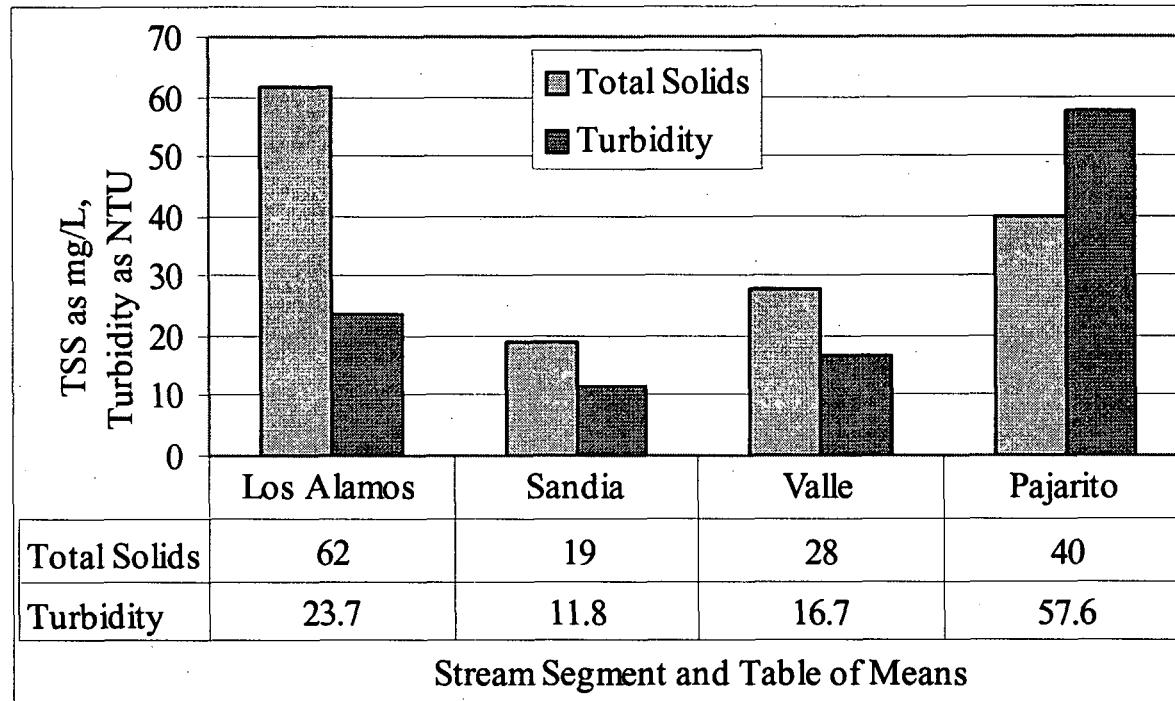
Figure 64. Average Turbidity (NTU) and Total Suspended Solids (mg/L) of Canyon Stream Segments, 1997.

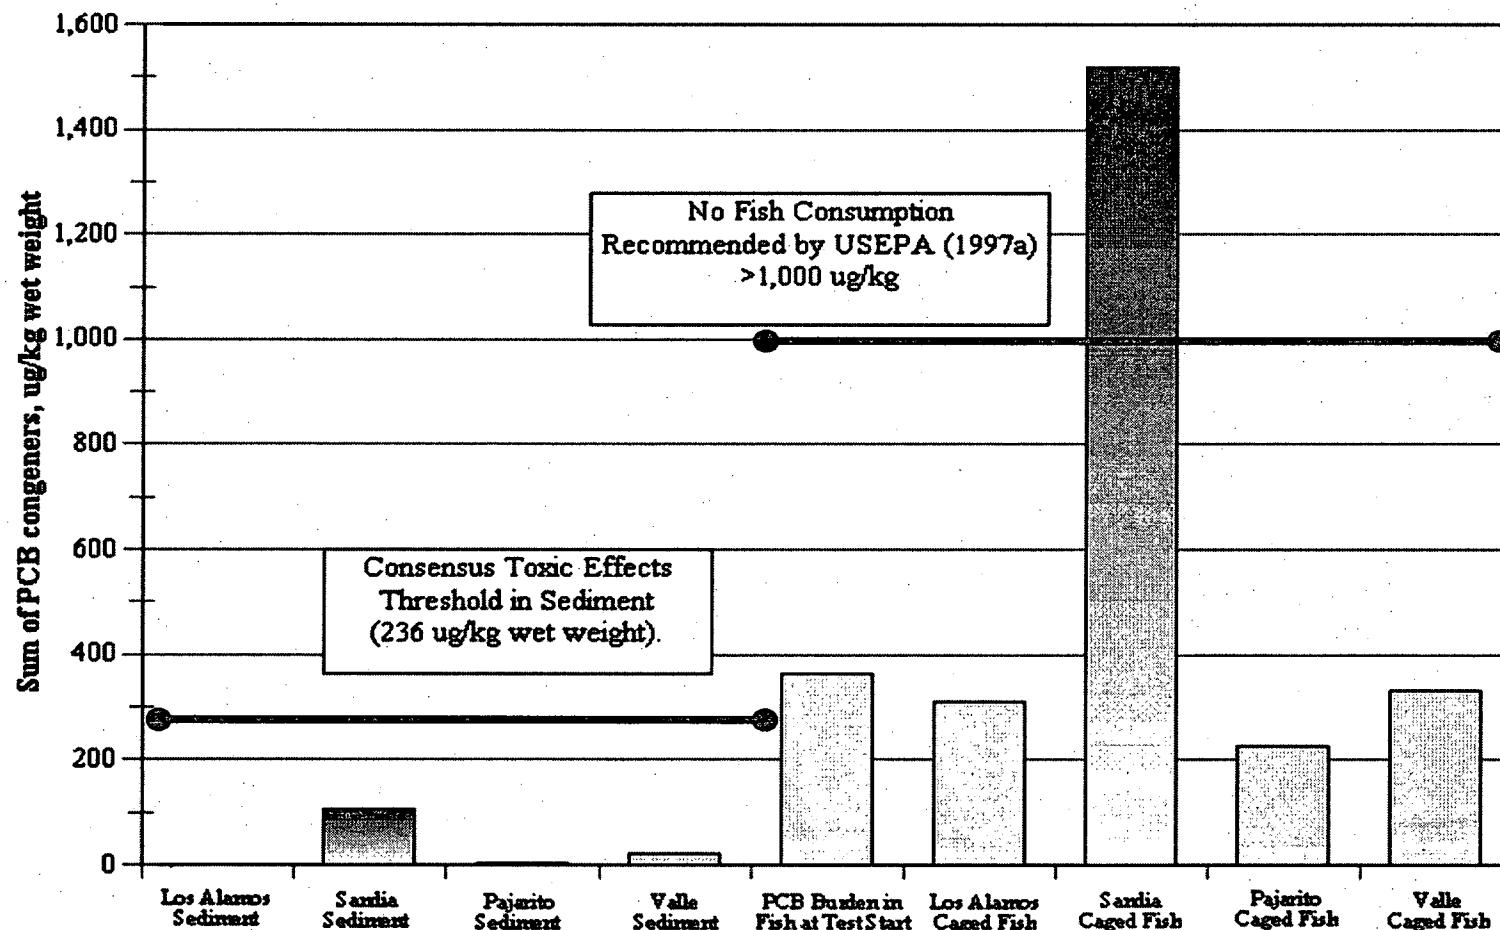
Figure 65. PCB congeners in Sediment and Caged Fish Collected for the Use Study Compared with Thresholds of Concern.

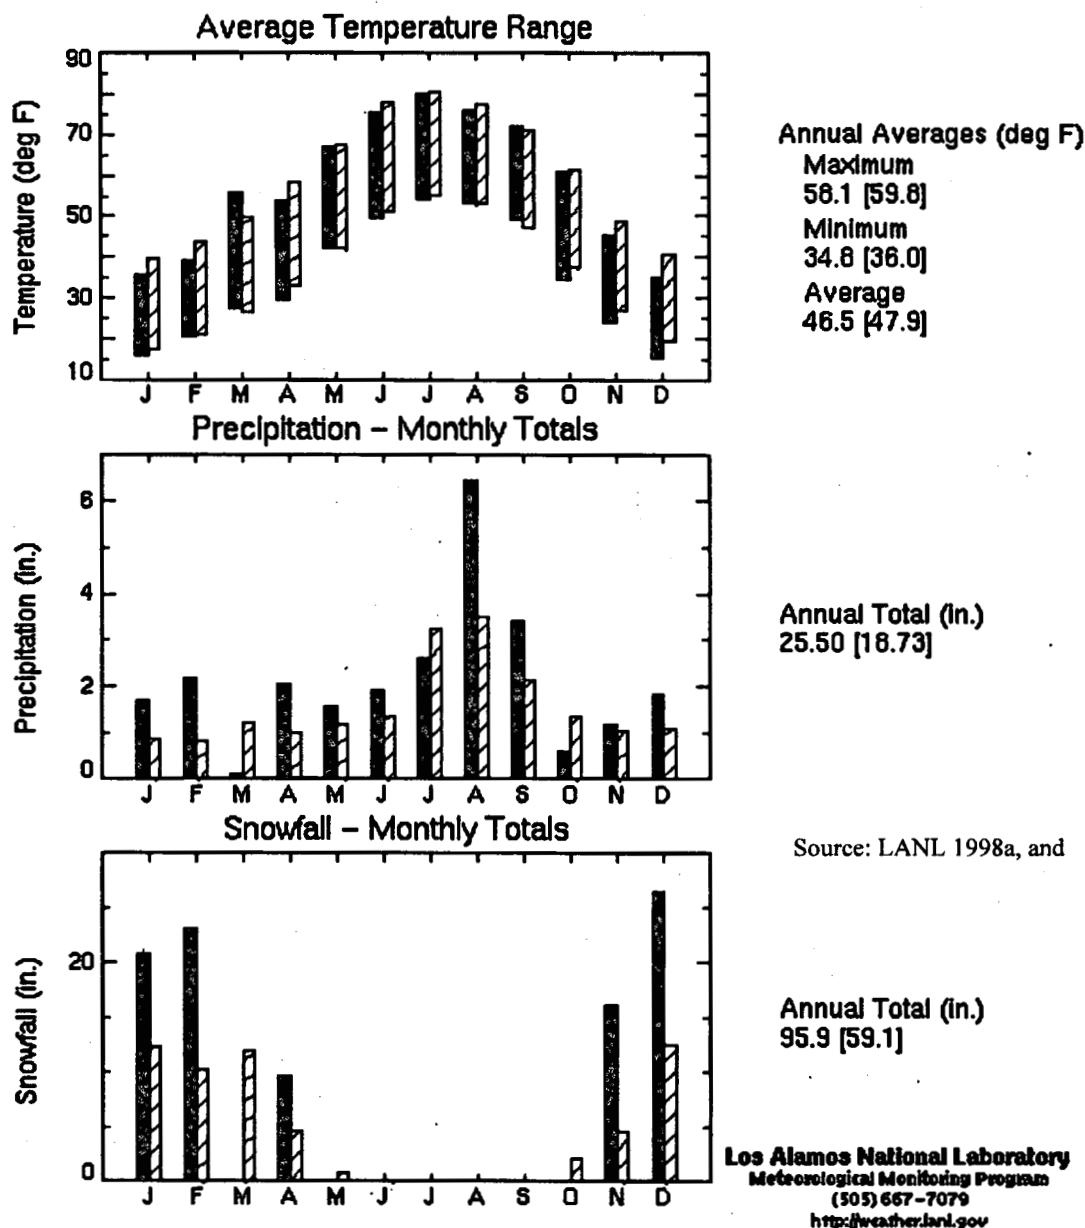
1997 Weather Summary
Los Alamos, New Mexico - TA-6 Station, Elevation 7424 ft
■ 1997 Values ▨ [Normal Values] 1961-1990

Figure 66. Summary of Precipitation and Air Temperature (°F) in 1997 at Technical Area 6 of the Los Alamos National Laboratory. (This Weather Station was near to the Stream Segments Evaluated During the Use Study).

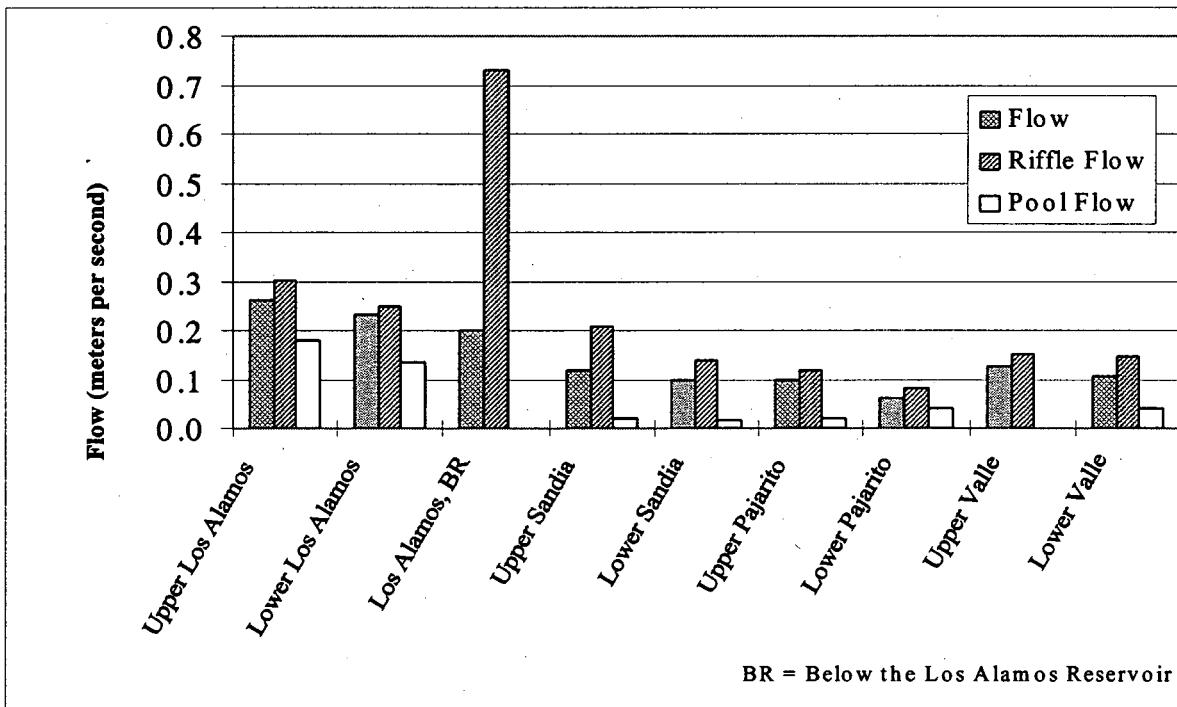
Figure 67. Average Stream Flow, Average Flow in Riffle Habitats, and Average Flow in Pool Habitats, Measured for Each Stream Reach in 1997.

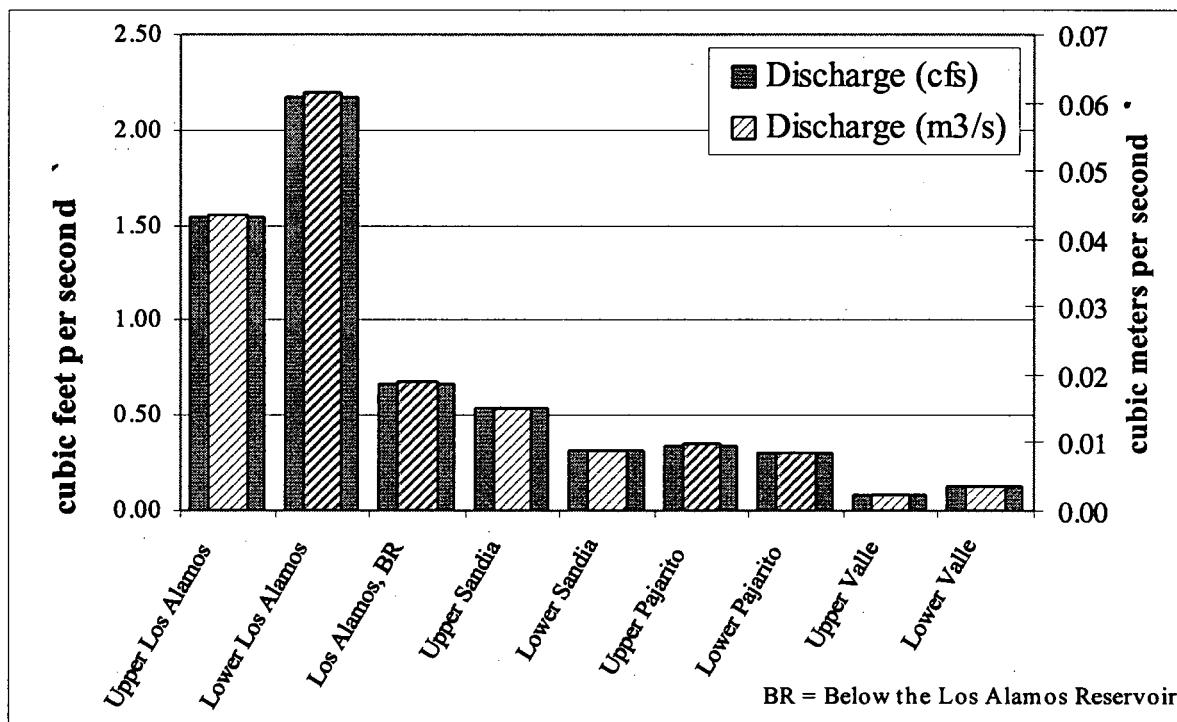
Figure 68. Average Stream Discharge (in cubic feet per second [cfs] and cubic meters per second [m³/s]) Measured for Each Stream Reach in 1997.
